## Sail Drive Diaphragm Change Lessons Learned

Volvo MD 2030 with MS25s saildrive fitted to Maxi 1100

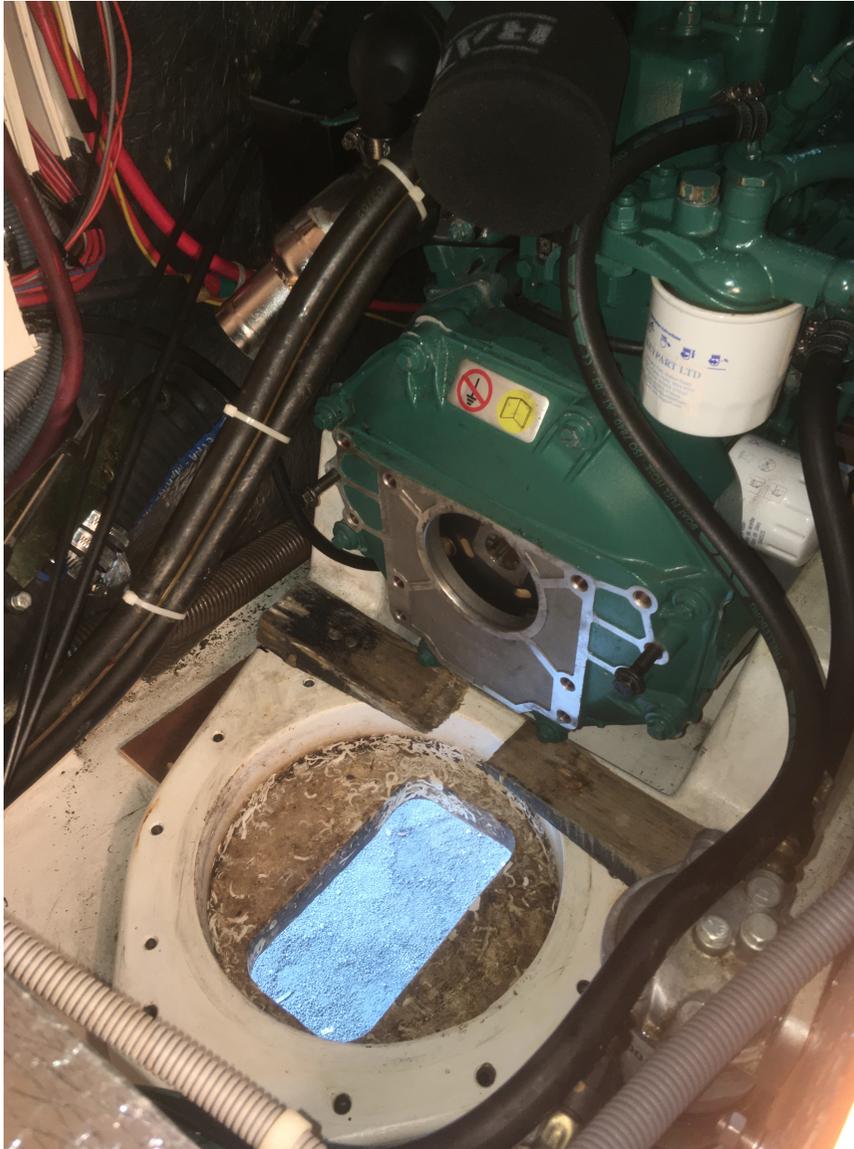
Saildrive removed, two gearbox bolts placed in outer holes and used to support engine on reassembly

- The repair instructions are misleading and suggest a 12mm dia bar to support gearbox, there are in fact two 12 mm holes on either side of gearbox so two short bars about 100mm long can be inserted in each side of the gearbox onto 100mm blocks.

- I used two of the M12 gearbox bolts with a rope stop to support the rear of the engine
- I used a ratchet strap around keel and saildrive to stop the saildrive swinging back when disconnected from engine. I also had made a prop and used wedges to hold saildrive when back in the boat.

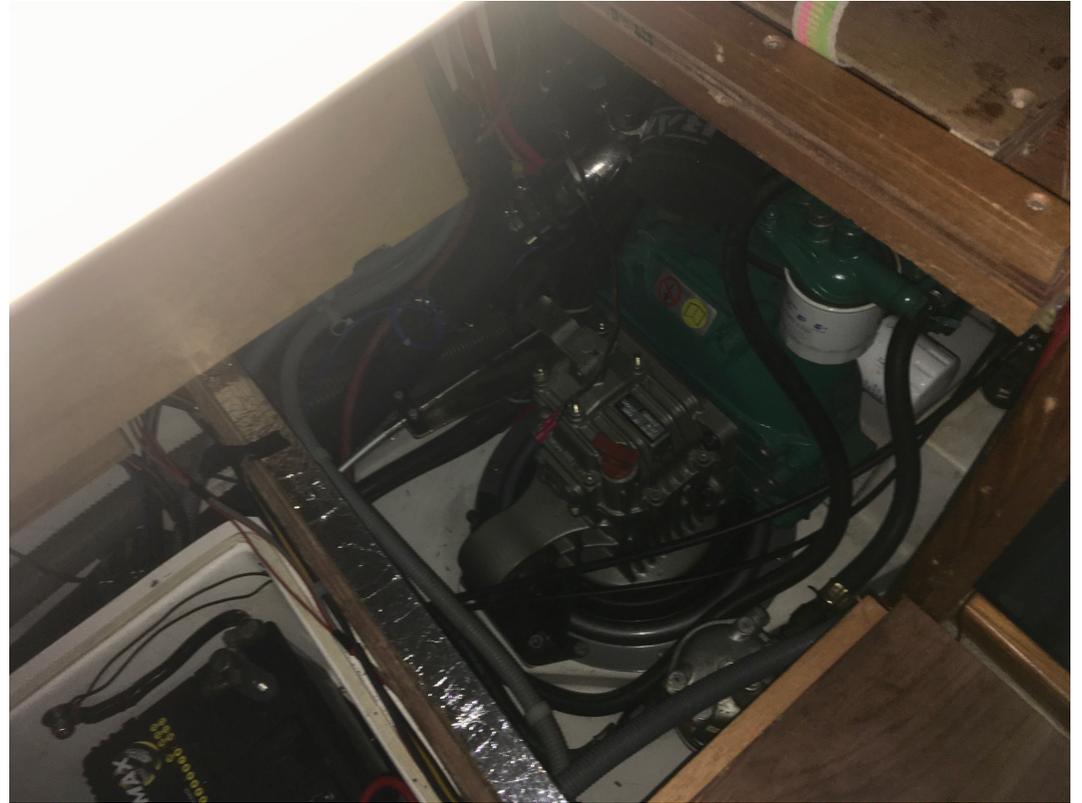
Bulkhead behind engine bay with sound proofing prevented saildrive being tipped back to get shaft through hull

- It was hard lifting the saildrive into the boat to remove it, I estimate saildrive is 30kg.
- I tried to do it without taking prop-shaft out, but I couldn't lift it far enough to swing backwards, through the hull. There is a bulkhead behind the engine bay. I then had to remove shaft from the saildrive which was then loose in the boat.

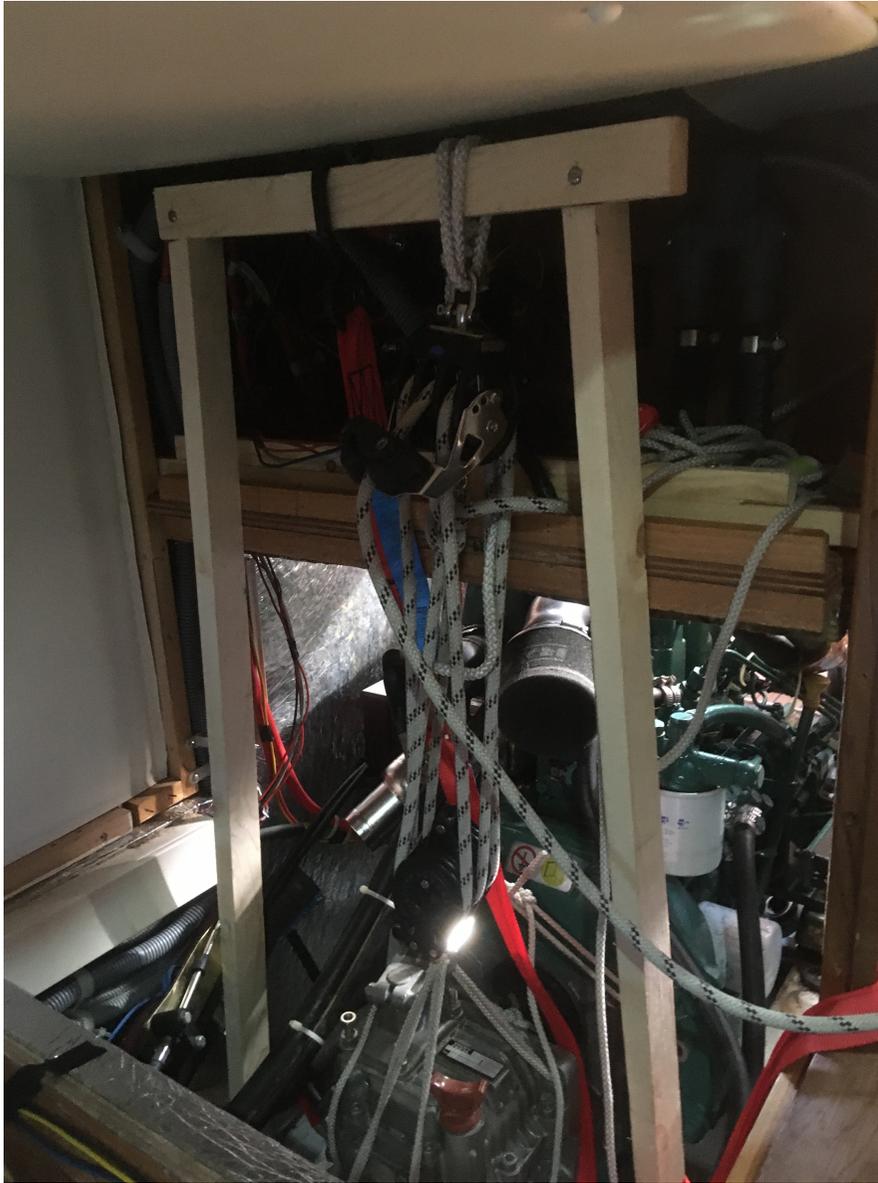
Wooden A frame, handy billy used to lower saildrive. Red ratchet strap supporting engine off two bolts

- Pressure test kit was a 6mm Tee, a small pressure gauge and a old car tyre valve soldered to a fitting.
- I bought some wood and made a simple A frame to lower saildrive back in using a handy billy.

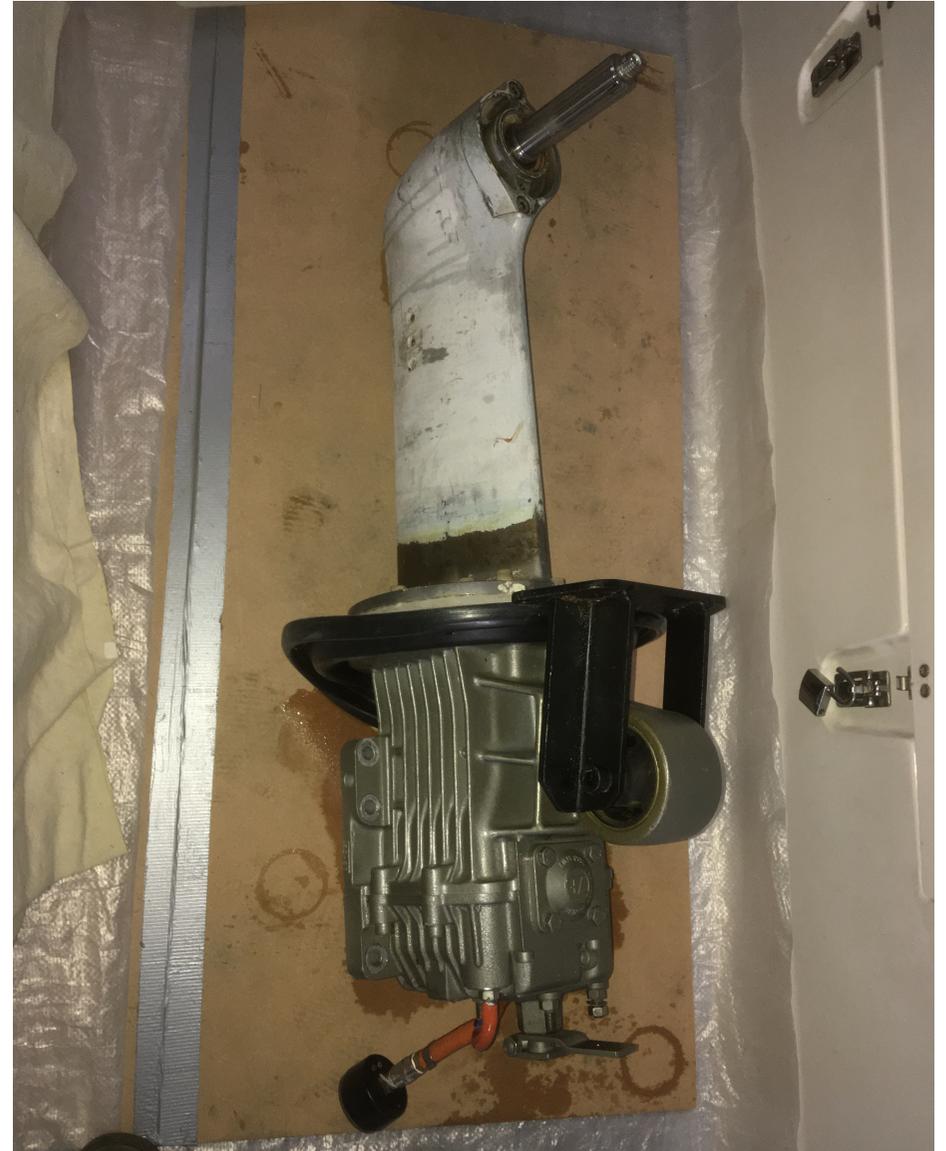
Cockpit floor covered in polythene and mdf sheet used as a bench. Saved carrying saildrive down ladder

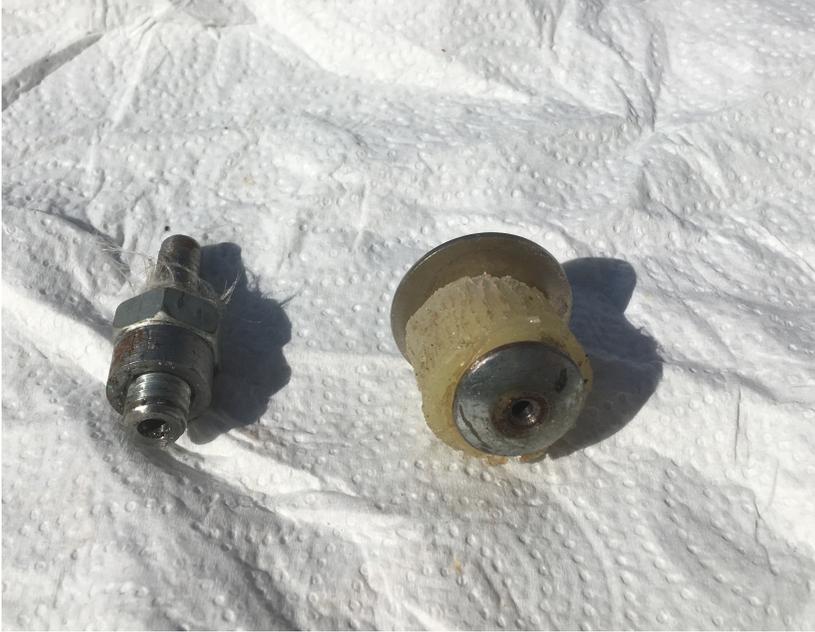
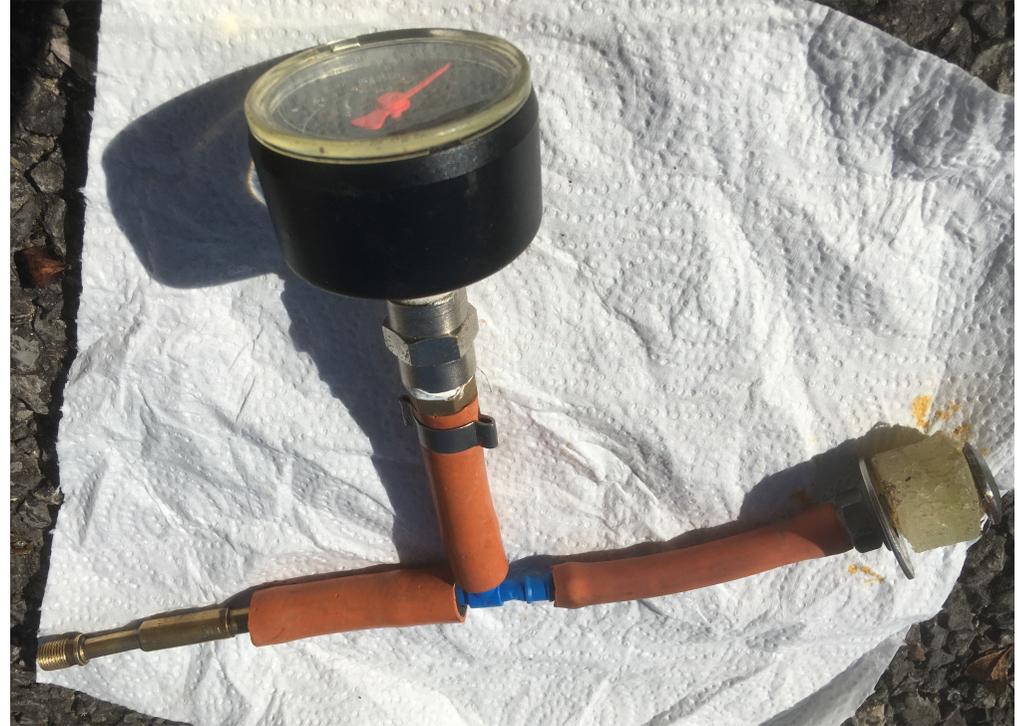
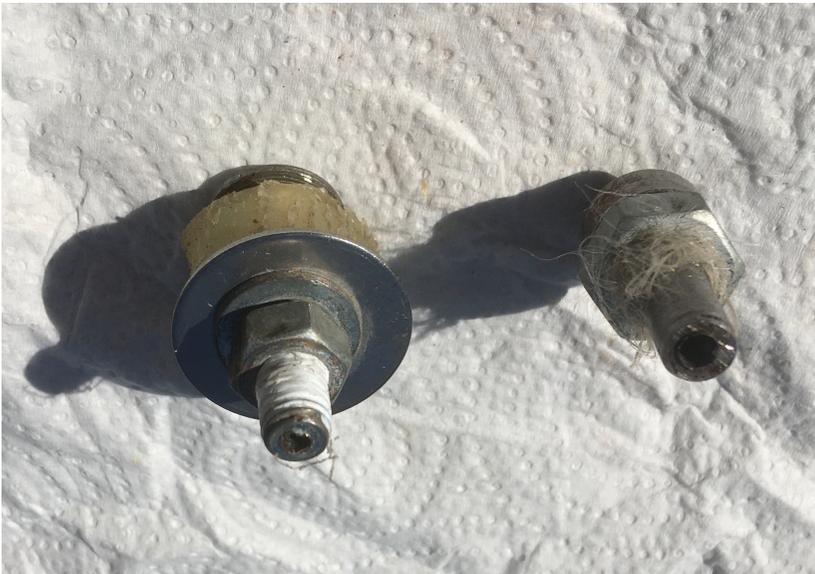
M10 stud drilled for pressure test. Discovered it was 3/8" UNC. Back up plan was a drilled coach screw with a soft rubber bung I made from silicon sealant, a bit like an expanding wine bottle stopper.

Pressure test kit is an old car tyre Schrader valve soldered into a hose tail, a Tee and a pressure gauge. Bicycle pump was awkward so I used 12v tyre pump from my car.

- I had minor corrosion on saildrive near the bolts which I cleaned and painted with Hammerite special metals primer, then hammerite paint.
- The leg should be pressure tested. I didn't know the thread size of the drain plug but guessed at M10 from recollection. I made up drilled threaded studs. I discovered when I removed the drain plug that the thread is 3/8" UNC. I had made a large soft silicon plug for the filler plug with a drilled clamping bolt, this sealed perfectly. I tested this before dismantling the saildrive. After reassembly I tested to 9psi which held for over 1 hour and probably would have for ever.
